Manhole Inspection Summary

Manhole # S39C__005MH

Insp Date: **8/25/08 9:25 AM**

Location Address: **1000 low st**

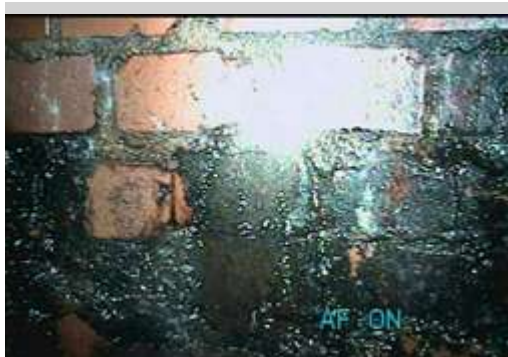
Defect 4

Infiltration: ☐ None ☐ Joint ☐ Cracks ☐ Mortar ☐ Roots ☒ **Wall**

infiltration running fast out of barrel wall near the nine

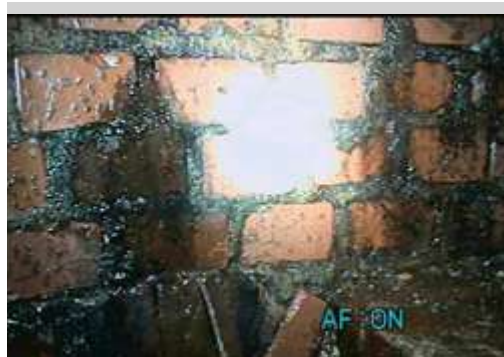
Defect 3

Comments **aaa..... The barrel has several spots of infiltration with water running fast and gushing above the 12**

infiltration above 12

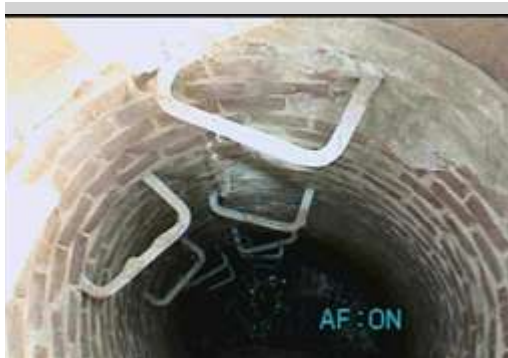
Defect 2

Steps Count: **9** Missing: **0** ☒ **Corroded**

steps

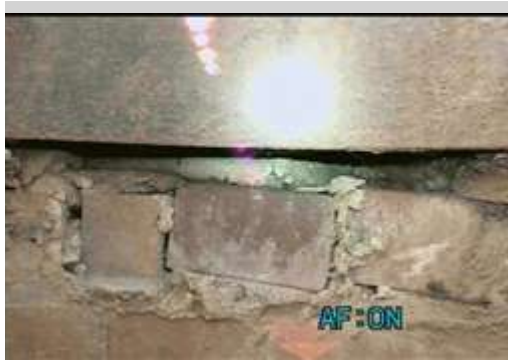
Defect 1

Condition: ☐ Sound ☒ **Cracked** ☐ Root Intrusion ☒ **Loose Brick** ☒ **Deteriorated**

loose bricks, cracked, frame adj

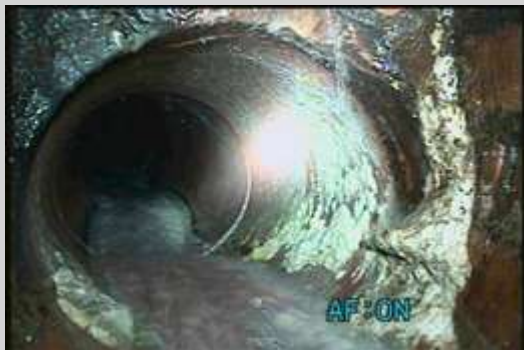
12 O'Clock Outflow

12 in. Circular Gravity Sewer
Pipe Out @ 12 O'Clock

Infiltration: **None** Pipe Seal Cond: **Unknown**

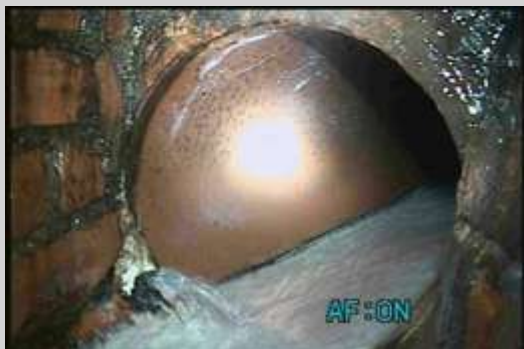
9 O'Clock Inflow

12 in. Circular Gravity Sewer
Pipe In @ 9 O'Clock

Infiltration: **None** Pipe Seal Cond: **Unknown**
